TOWN OF MOUNT HOLLY

Star Lake Dam

Presentation by
Shawn Patenaude, PE

DuBois
& King
inc.

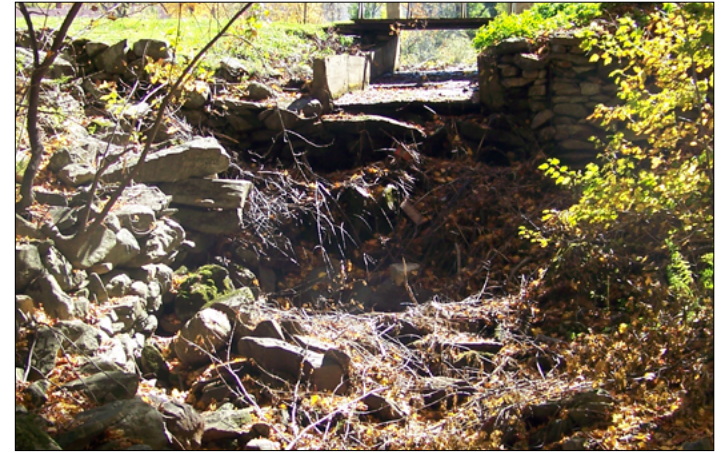
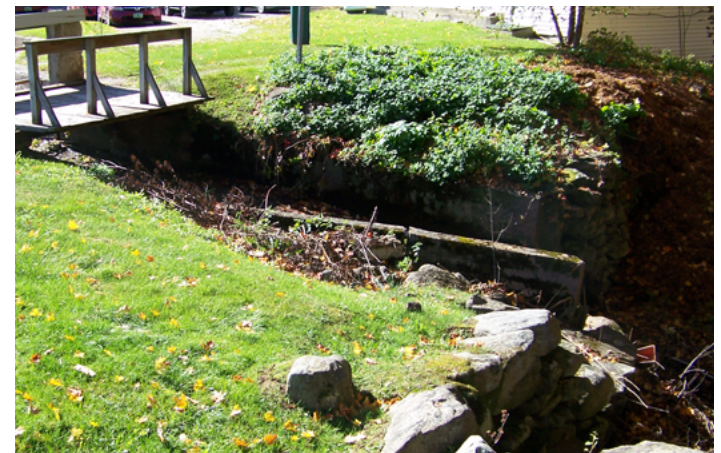
Common Dam Deficiencies

- Deteriorating concrete: spalling, delamination, cracking, typical wear
- Eroded embankment: overtopping, uncontrolled discharge, head cutting in the downstream channel
- Inadequate spillway hydraulic capacity: at historic water level (1846.65 +/-) overtopping occurs during a 4.40-inch rainstorm, <25-year return interval

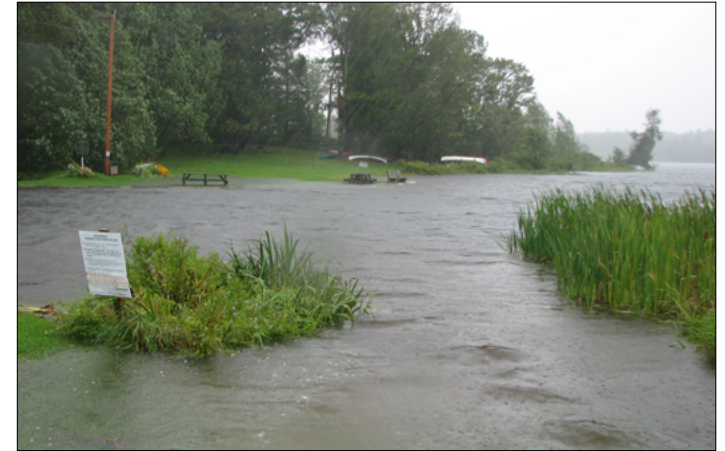
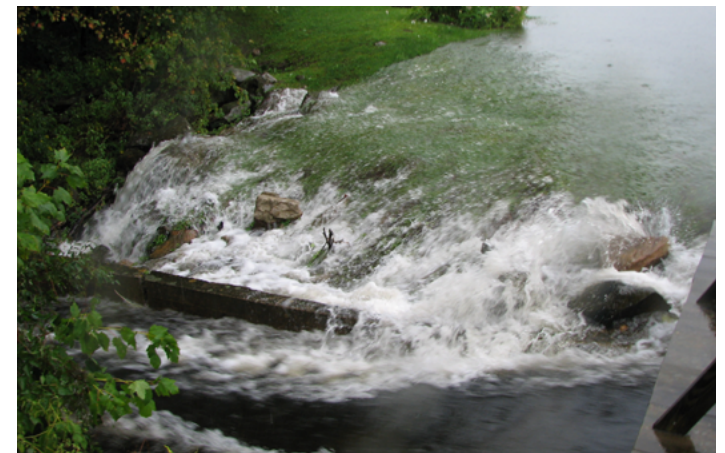
Tropical Storm Irene

- 6" average regional rainfall (NWS stations)
- 8" recorded in the Star Lake watershed
- Estimated peak water level was 1848.25 during Irene, with starting water surface at 1845.15
- If at historic water level, the estimated peak water level during Irene would have been 1848.82
- Prolonged overtopping = more damage

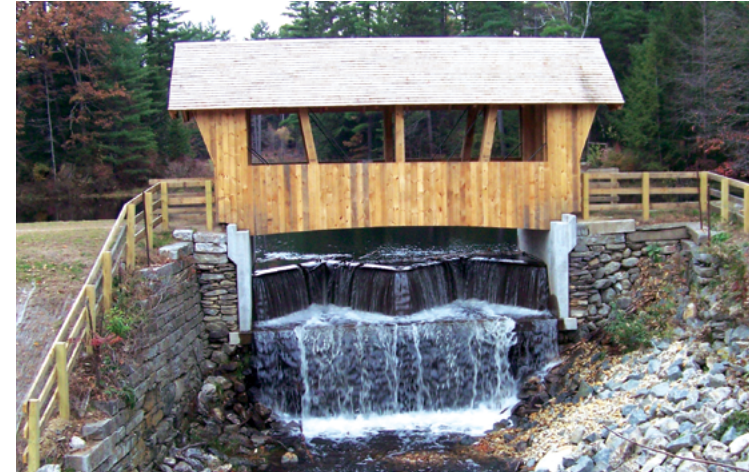
Alternative 1 - Overflow Spillway with Labyrinth Weir

- New concrete training walls
- Articulated concrete blocks on right at beach area
- Concrete overflow section consisting of a 1-cycle labyrinth weir spanning 25 (weir length of 38 feet)
- Rising stem sluice gate
- Parapet wall along the existing cut-off wall
- Extend the left cut-off wall to the boat launch

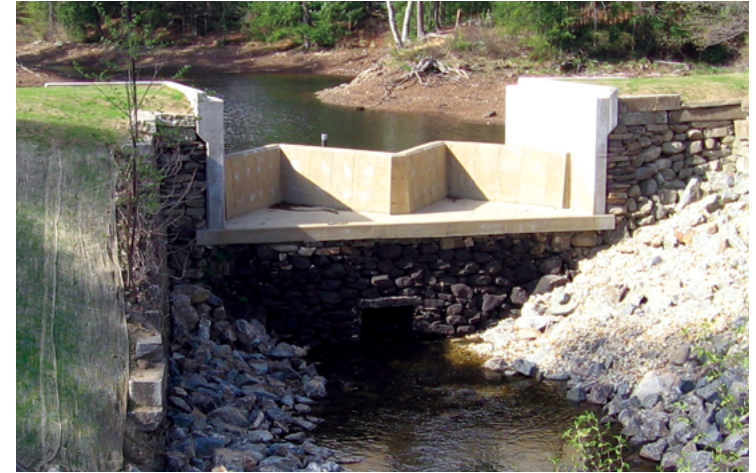
Alternative 1 - Summary

- New concrete training walls
- Articulated concrete blocks on right at beach area
- Concrete overflow section
- Rising stem sluice gate
- Parapet wall along the existing cut-off wall
- Extend the left cut-off wall to the boat launch

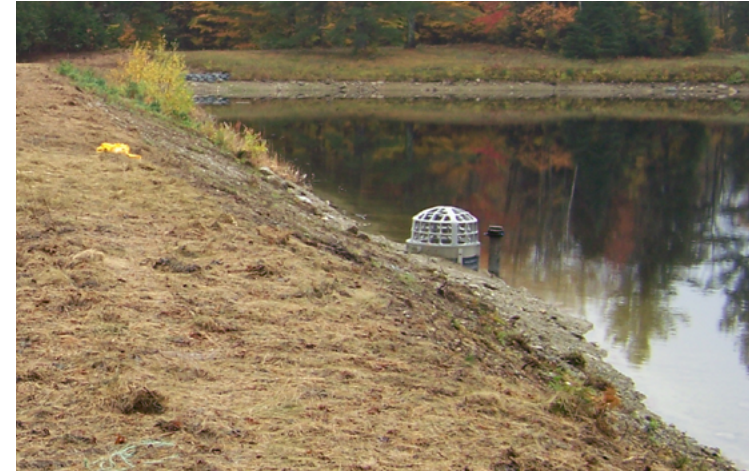
Alternative 2 - Drop Inlet Structure

- Rebuild earth embankment
- Regrade top of dam
- 10-foot diameter drop inlet with 5-foot diameter outlet barrel
- Articulated concrete blocks on right at beach area
- Parapet wall along the existing cut-off wall
